Investigation of the Performance of the New Orleans Flood Protection Systems in Hurricane Katrina on August 29, 2005

Volume I: Main Text and Executive Summary

**Final Report
July 31, 2006**

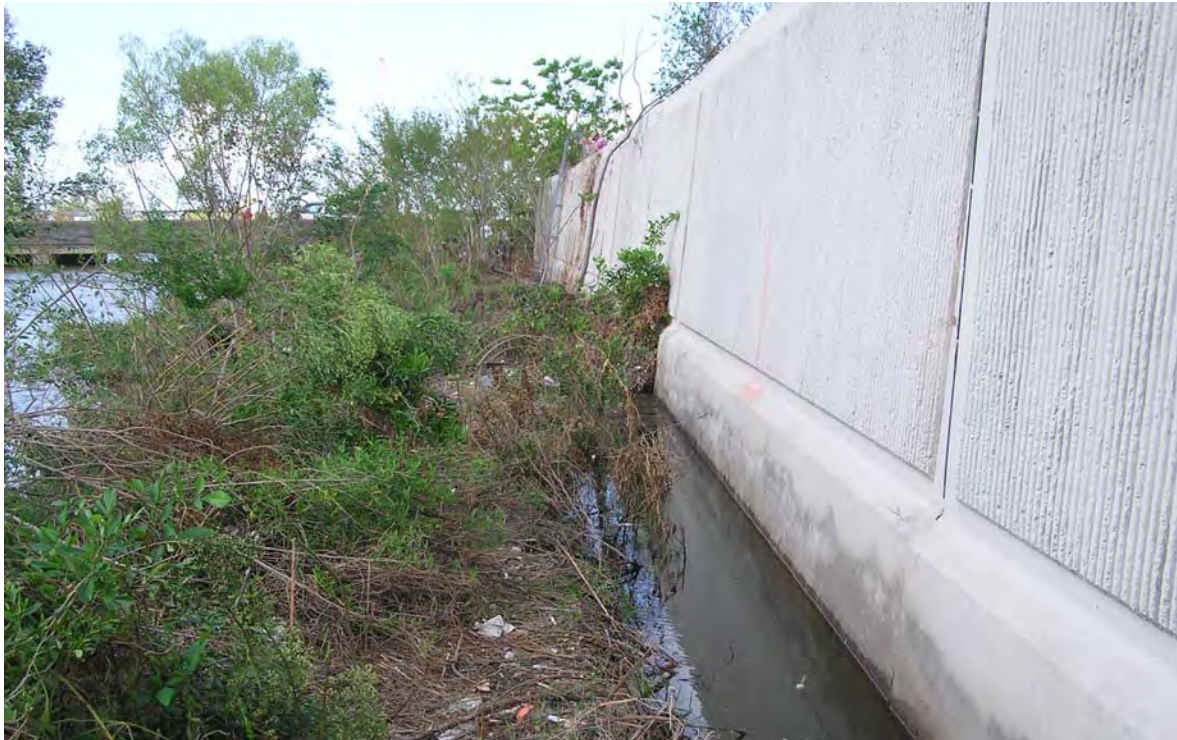
Figure 8.114 shows a view of the inboard toe of the “distressed” (displaced) embankment and floodwall section on the east shoreline, taken on the outboard (water) side. As shown in this photo, the concrete floodwall leaned away from the canal, and a gap with a maximum width of 2.5 feet (and a common width of 1.5 to 6 feet) opened between the outboard side of the earthen levee embankment and the concrete floodwall (and its supporting sheetpile curtain.)

This exactly fits with the observed field data. The "sinkholes" at the crest of the embankment on the east side were the result of tilting of the slightly displaced floodwall, and the resulting opening of a gap between the floodwall and the embankment into which embankment soils could fall. This correlates with the observation the "sinkhole features" were all narrow, and were all parallel and adjacent to the floodwall (see Figures 8.114 and 8.117.)

Figure 8.114: Water-filled gap at outboard side of east bank distressed section.

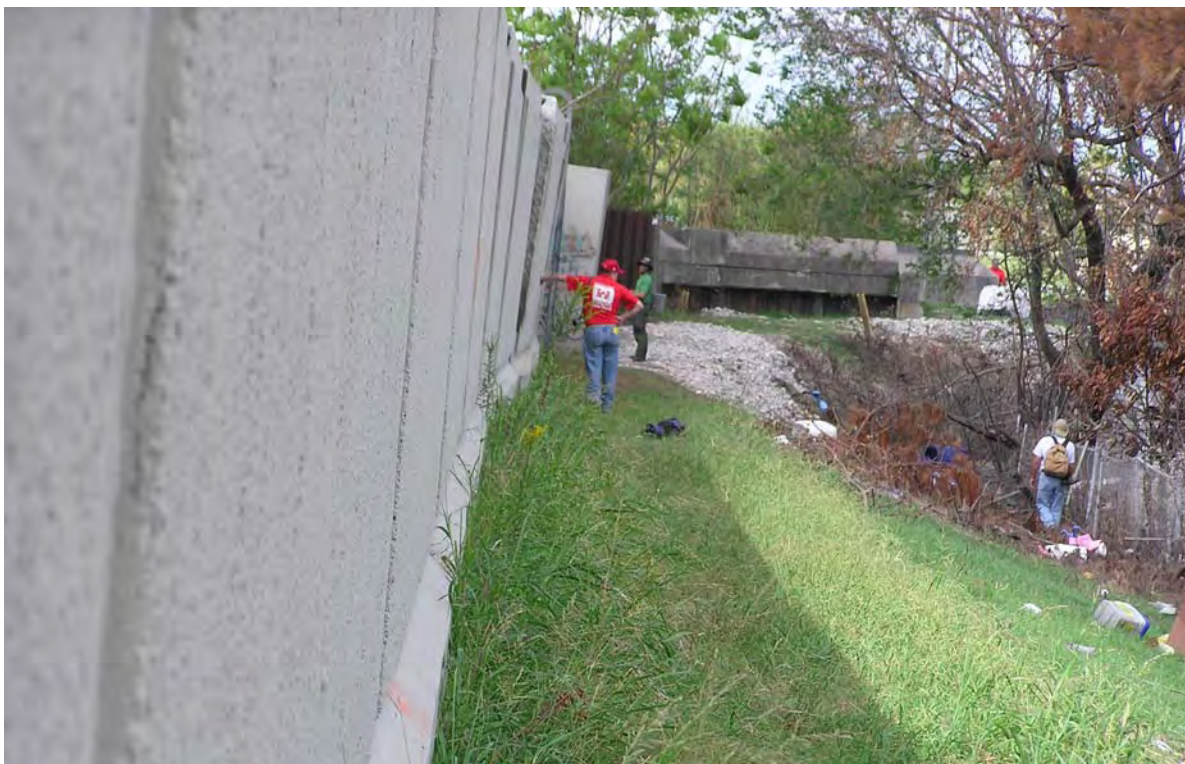
Figure 8.115 shows the other side of this same floodwall section. As shown in this photo, the displaced floodwall leaned to the inboard with a readily discernable tilt of up to 8°. The next photo, Figure 8.116, shows conditions along the inboard base of the floodwall (at the feet of the photographer who took the photo of Figure 8.115.) A series of apparent “sinkholes” occurred along the inboard side contact between the concrete floodwall and the crest of the earthen levee at this location.

Figure 8.115: Inboard leaning floodwalls on the other side of the floodwalls shown above in Figure 8.112.

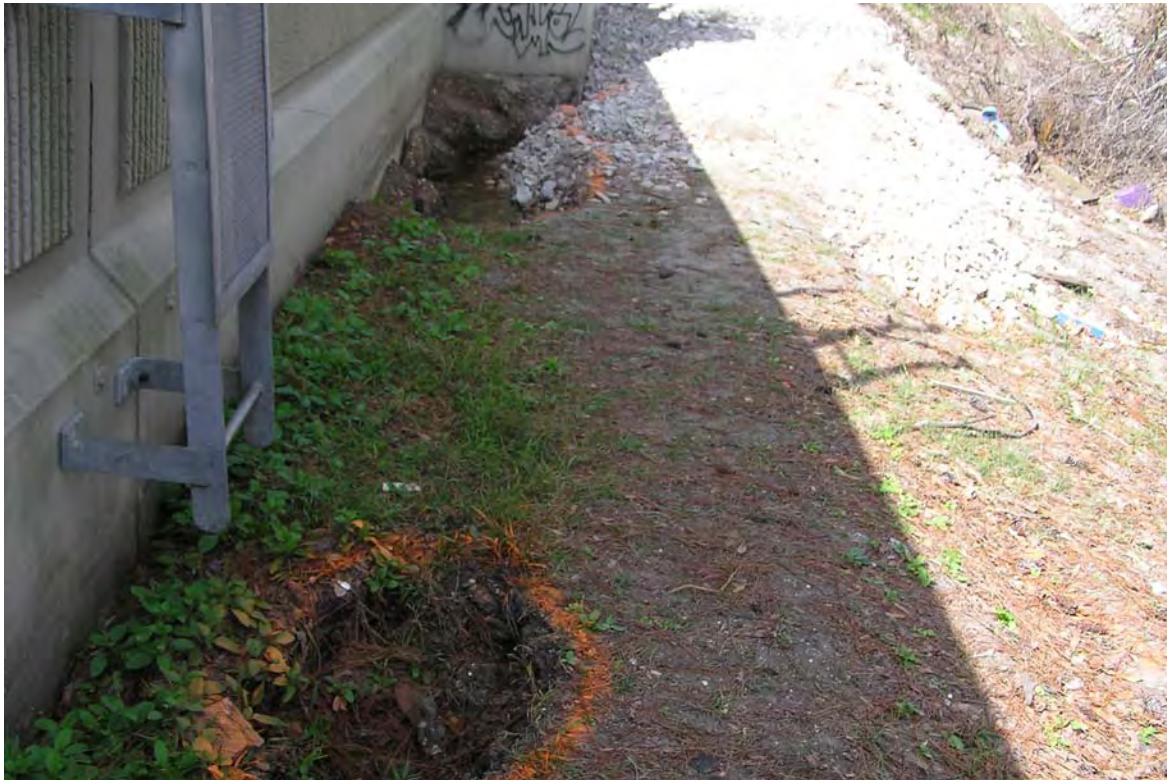
Figure 8.116: Sinkholes along the contact at the inboard side base of the floodwall and the levee crest.

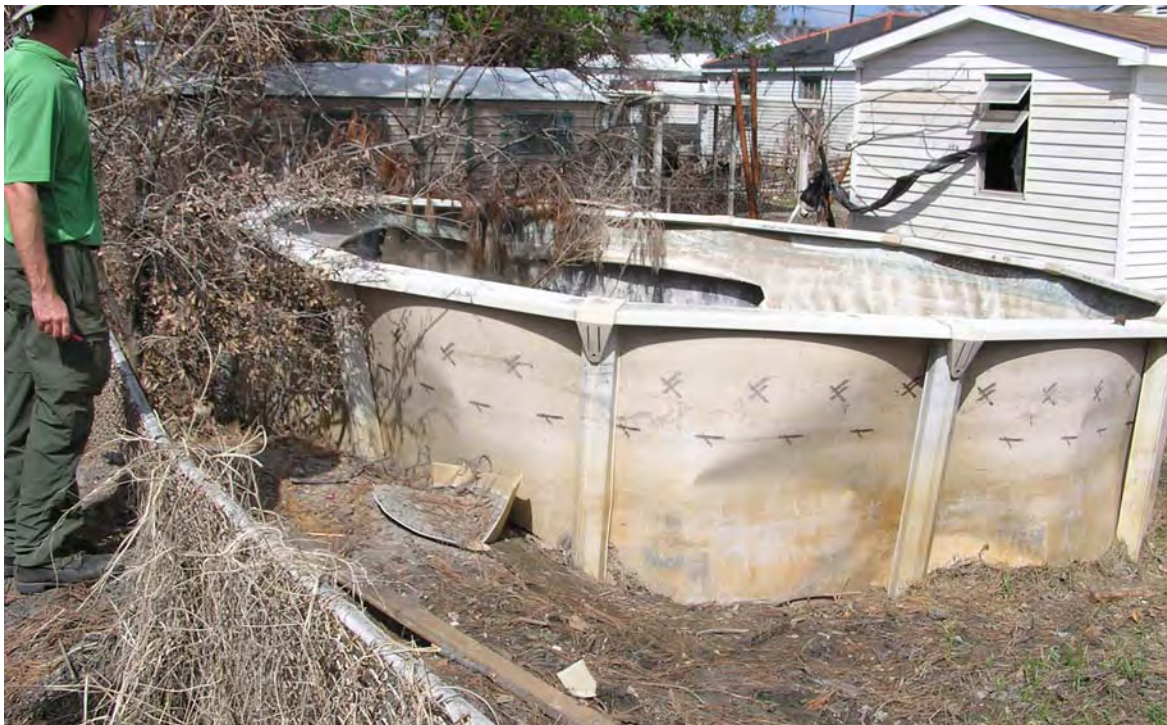
Figure 8.117 shows conditions at the inboard toe immediately below the sinkholes of Figure 8.116. A prominent sand boil feature, with sandy ejecta, occurred at this location. Less apparent, but important, was the hummocky wrinkling of the nearly level ground inboard of the toe of the levee, and the slight overthrust feature adjacent to the sand boil. This overthrust feature was apparently missed by many field investigators, but our team noted it and went back and excavated it during our subsequent field boring, sampling and CPT program and found that it was indeed the toe thrust of the beginning of a translational instability feature.

Figure 8.117: Sand ejecta from toe boil, and edge of toe thrust feature; London Avenue canal (north) east bank distressed section.

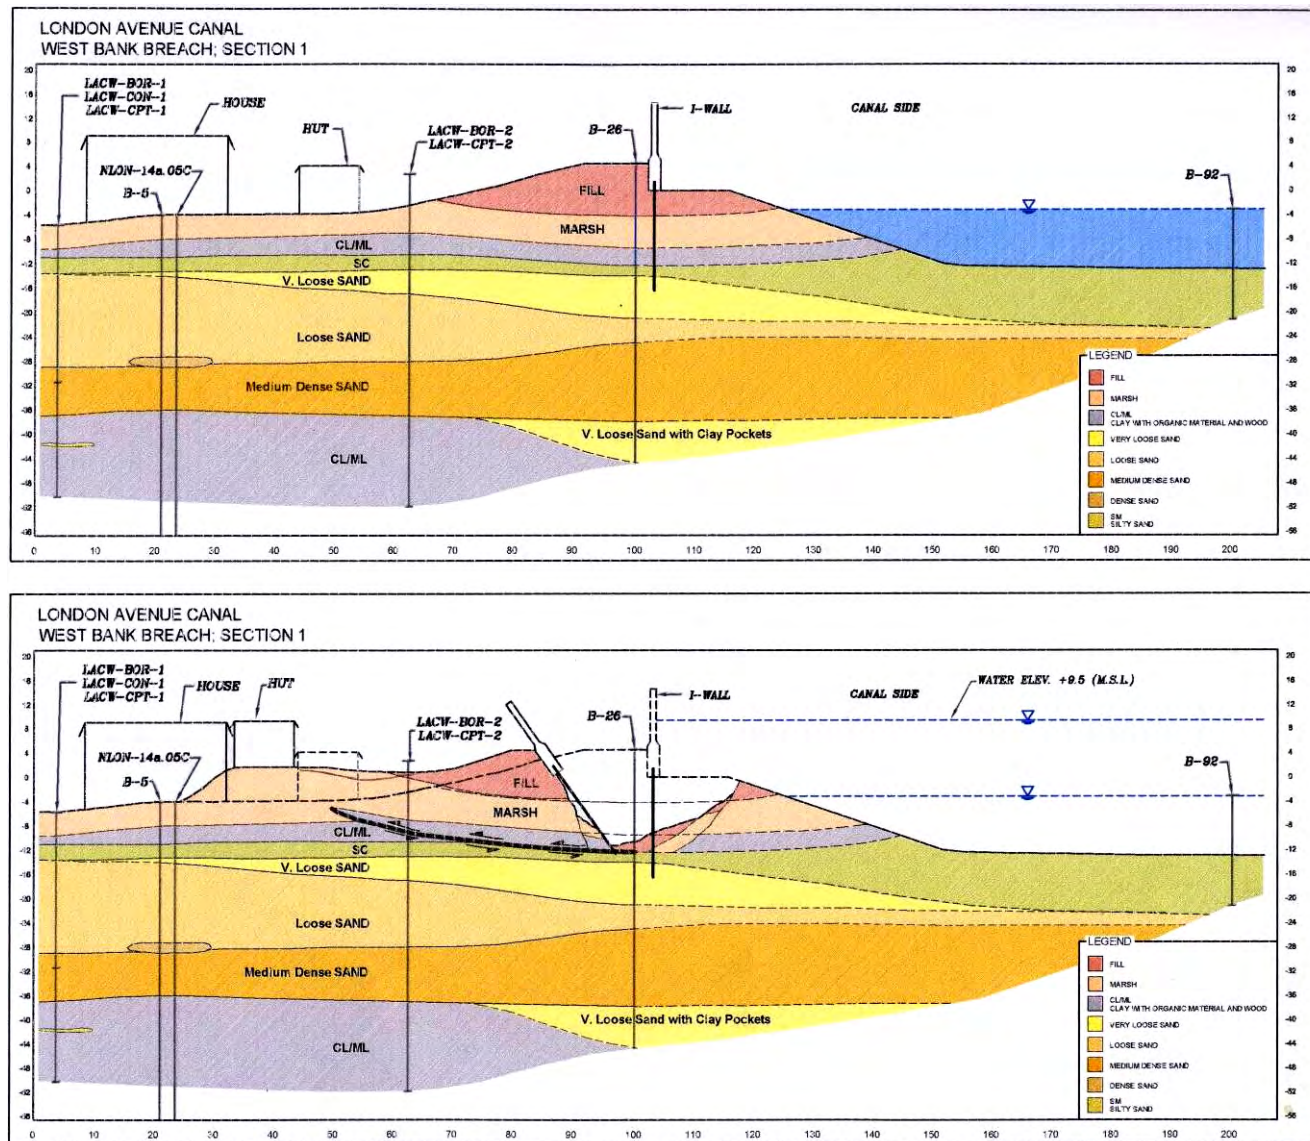
Figure 8.118(a) shows a cross-section through the west side breach prior to Katrina, and Figure 8.118(b) shows this same section after the failure. The failure on the west side was a translational failure of the embankment, sliding along the interface between the foundation sands and the overlying less pervious layer of silty clay (CL/ML).

Figure 8.118: Pre-Katrina and Post-Katrina cross-section for London Avenue Canal North, west bank breach section.

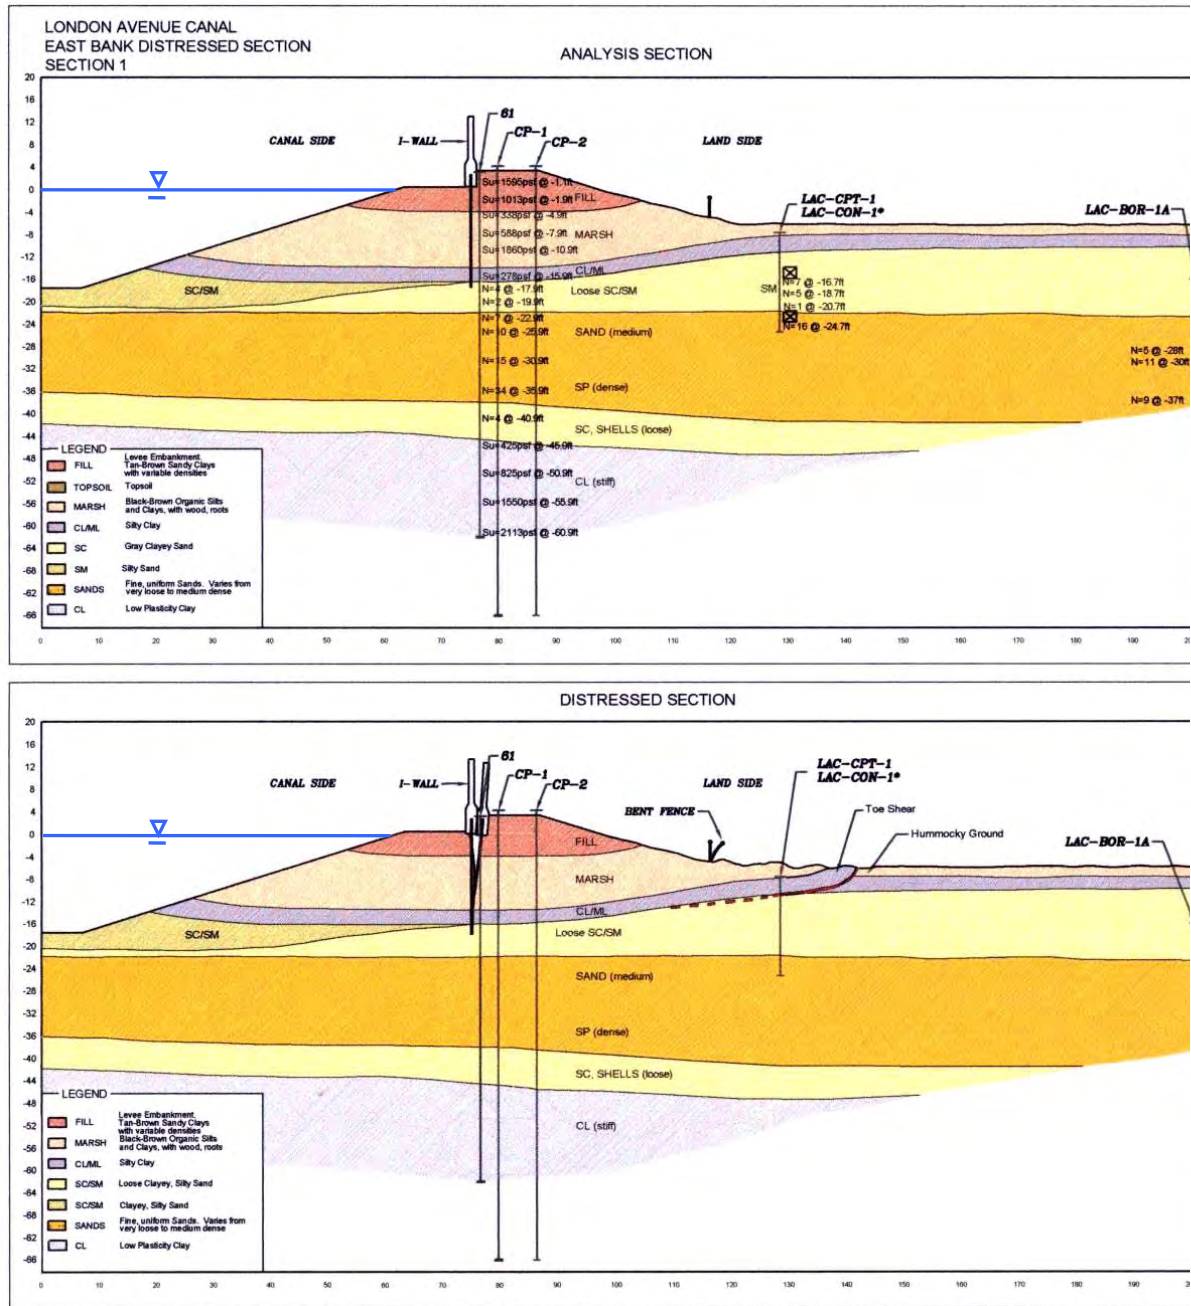
Figure 8.119(a) shows a cross-section through the east side “distressed” section prior to Katrina, and Figure 8.119(b) shows this same section after the hurricane. The displacement and tilting of the floodwall was the result of the initiation of slippage, once again at the interface between the foundation sands and the overlying less pervious layer of silty clay. Unlike the west bank, this slippage progressed only enough to produce displacements of approximately 1.5 to 2.5 feet, whereupon these movements were arrested as the failure and breaching on the opposite bank rapidly drew down the canal water level and reduced the lateral push against the sheetpile curtain and floodwall.

Figure 8.119: Pre-Katrina and Post-Katrina cross-section for London Avenue Canal North, east bank, distressed section.

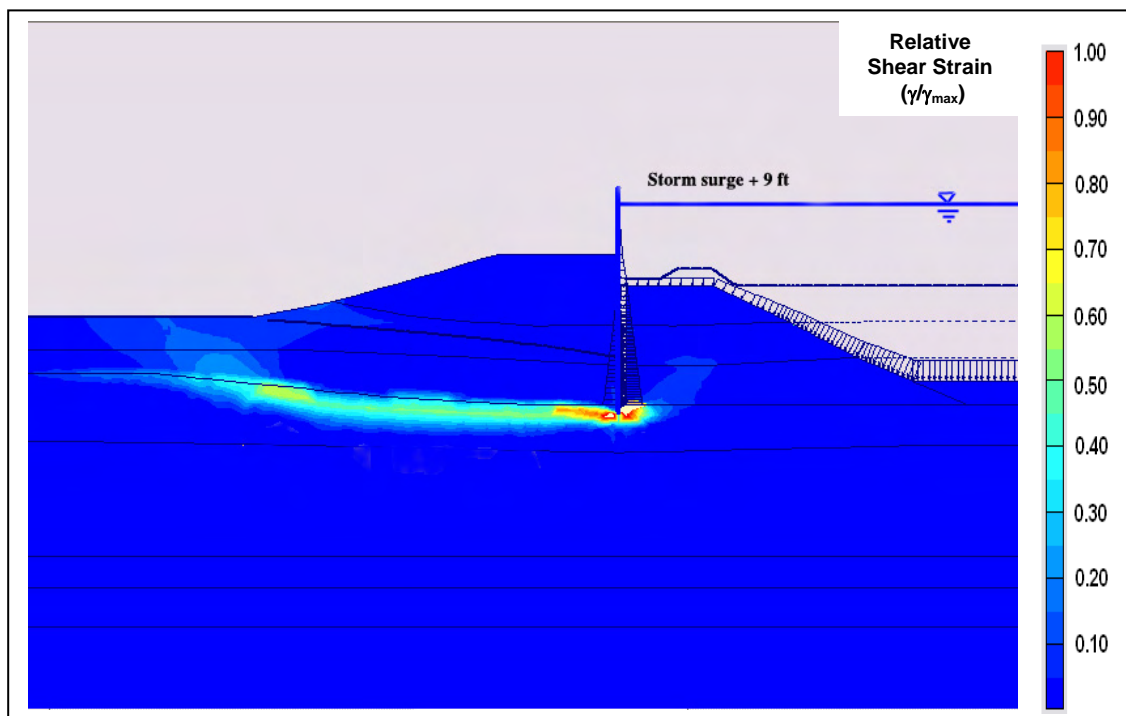
Figure 8.132: Normalized shear strain contours (shear strain divided by strain to failure) for a storm surge at Elev. + 9 feet (MSL) at the London Avenue Canal breach site (west bank); gapping at outboard toe of floodwall is developed to full depth.

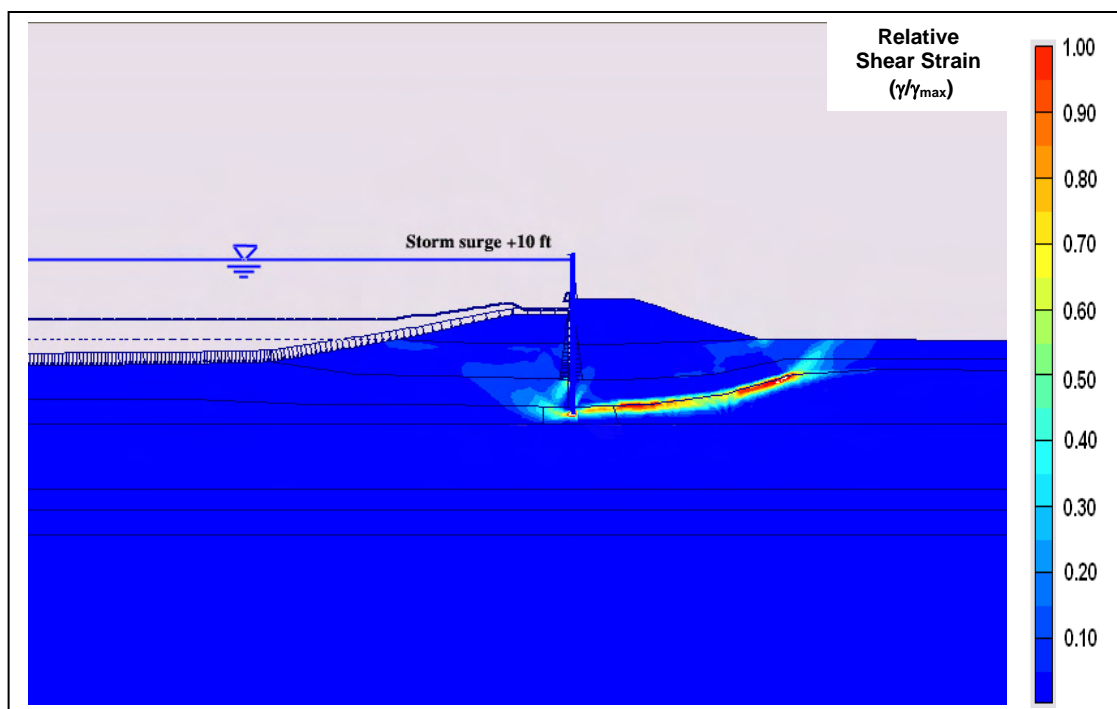
Figure 8.133: Normalized shear strain contours (shear strain divided by strain to failure) for a storm surge at Elev. + 10 feet (MSL) at the London Avenue Canal distressed site (east bank); gapping at outboard toe of floodwall is developed.

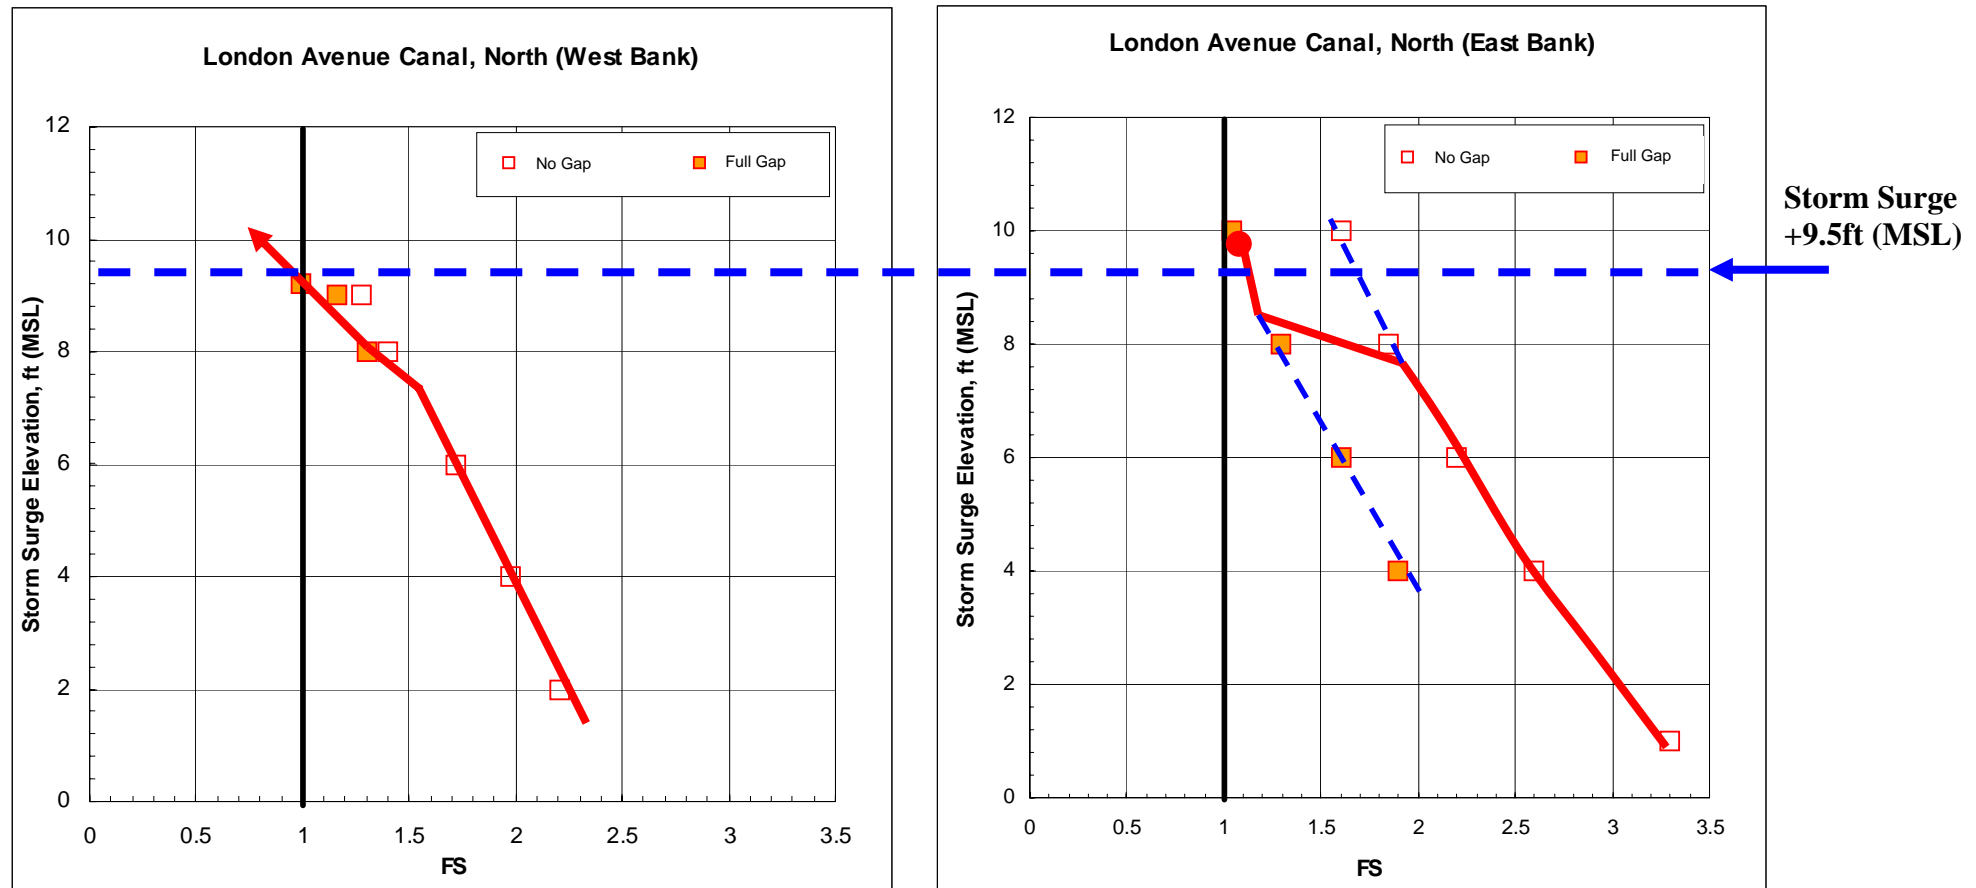
Figure 8.136: Calculated Factors of Safety for two modes based on PLAXIS analyses of the London Avenue Canal breach and distressed section for various canal water elevations; showing the best-estimated path to failure.

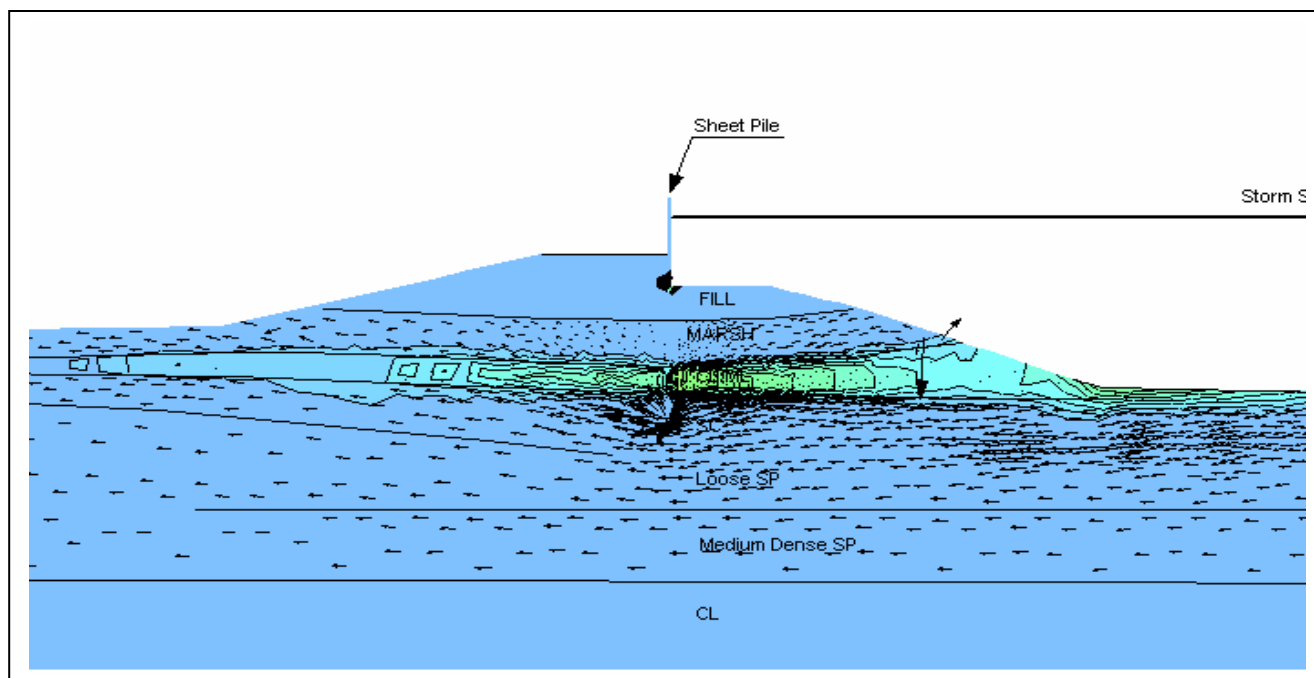
Figure 8.141: Hydraulic gradient contours without the gapping in the outboard toe of the floodwall, London Avenue Canal North, West bank. Storm surge at 9ft (MSL). Exit gradient at the inboard toe is 0.20.

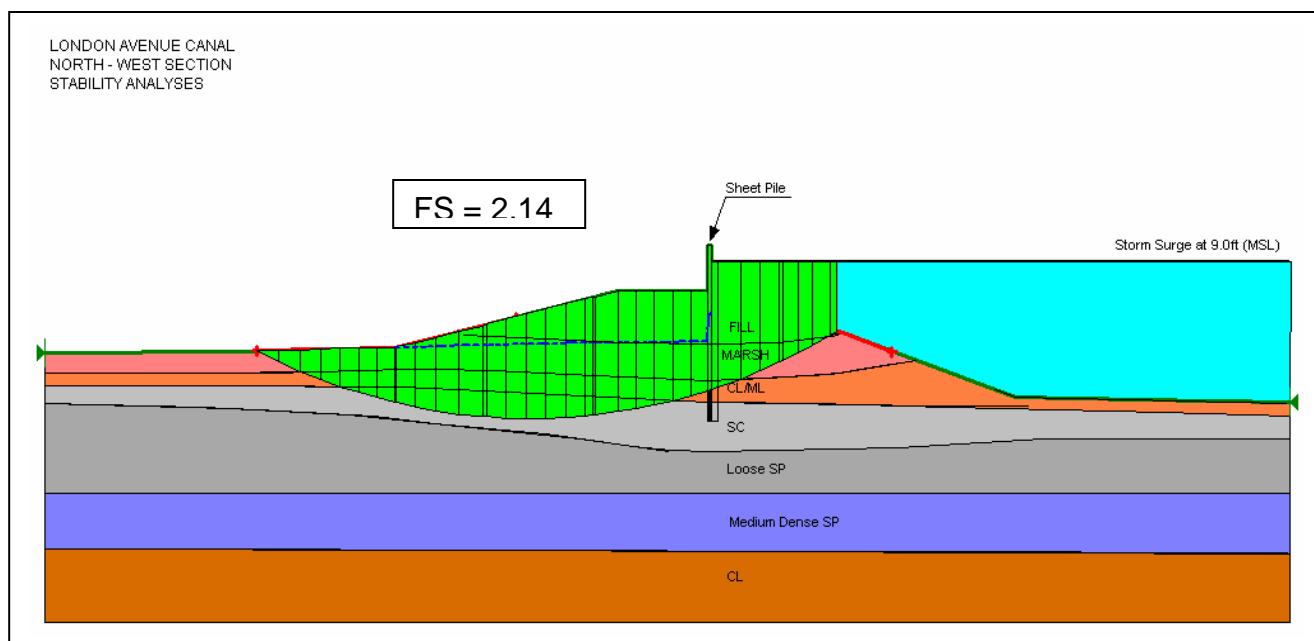
Figure 8.142: Critical failure surface without the gapping in the outboard toe of the floodwall, London Avenue Canal North, West bank. Storm surge at 9ft (MSL).

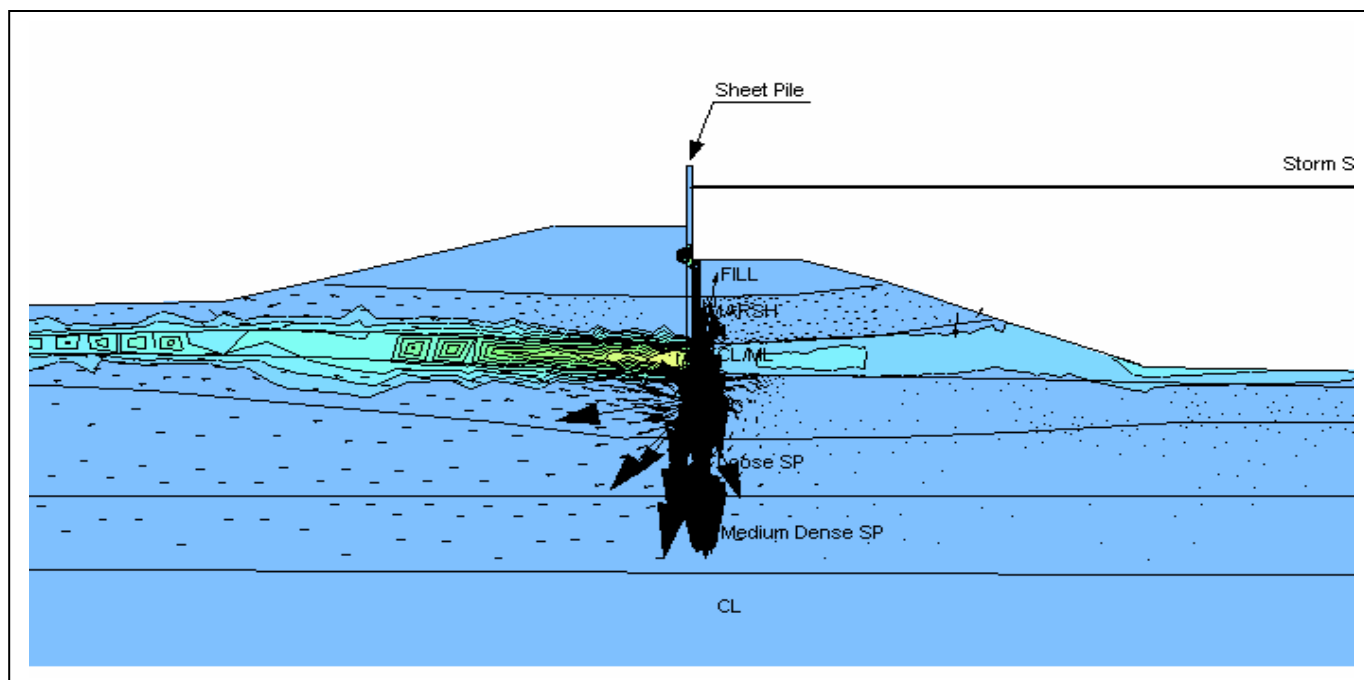
Figure 8.145: Hydraulic gradient contours with the gapping in the outboard toe of the floodwall, London Avenue Canal North, West bank. Storm surge at 9ft (MSL). Exit gradient at the inboard toe is 0.32.

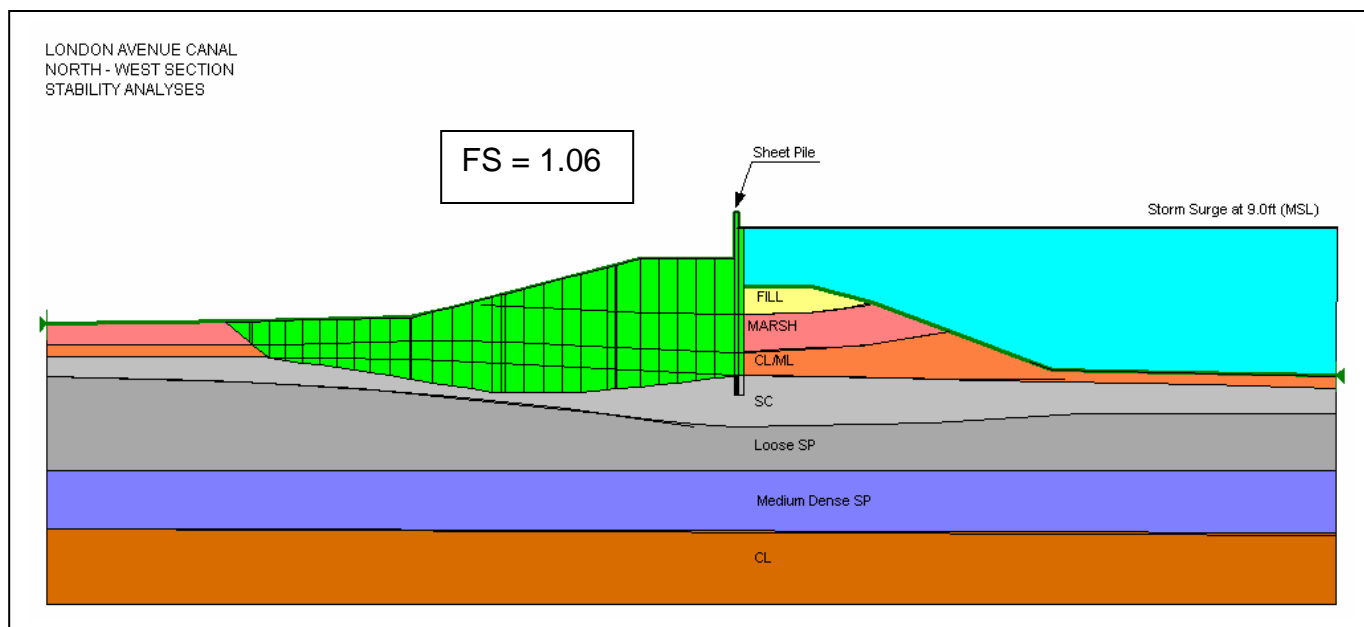
Figure 8.146: Critical failure surface with the gapping in the outboard toe of the floodwall, London Avenue Canal North, West bank. Storm surge at 9ft (MSL).

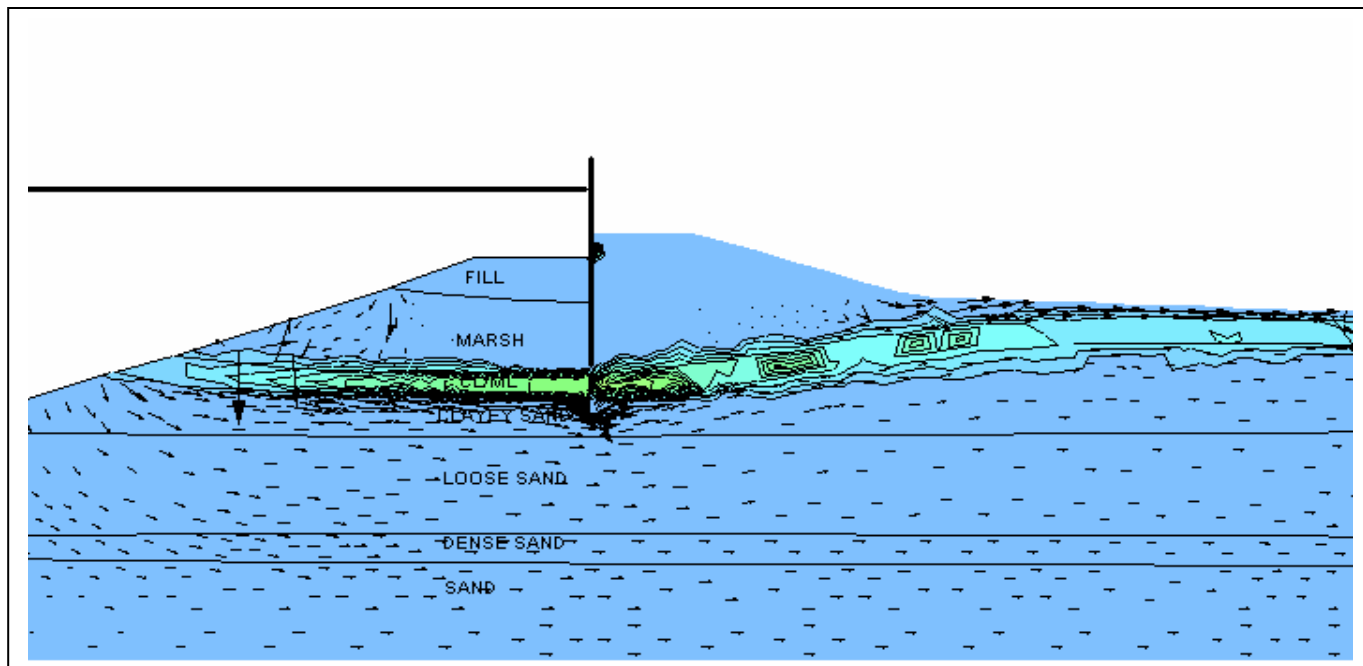
Figure 8.152: Hydraulic gradient contours without the gapping in the outboard toe of the floodwall, London Avenue Canal North, East bank. Storm surge at 9ft (MSL). Exit gradient at the inboard toe is 0.20.

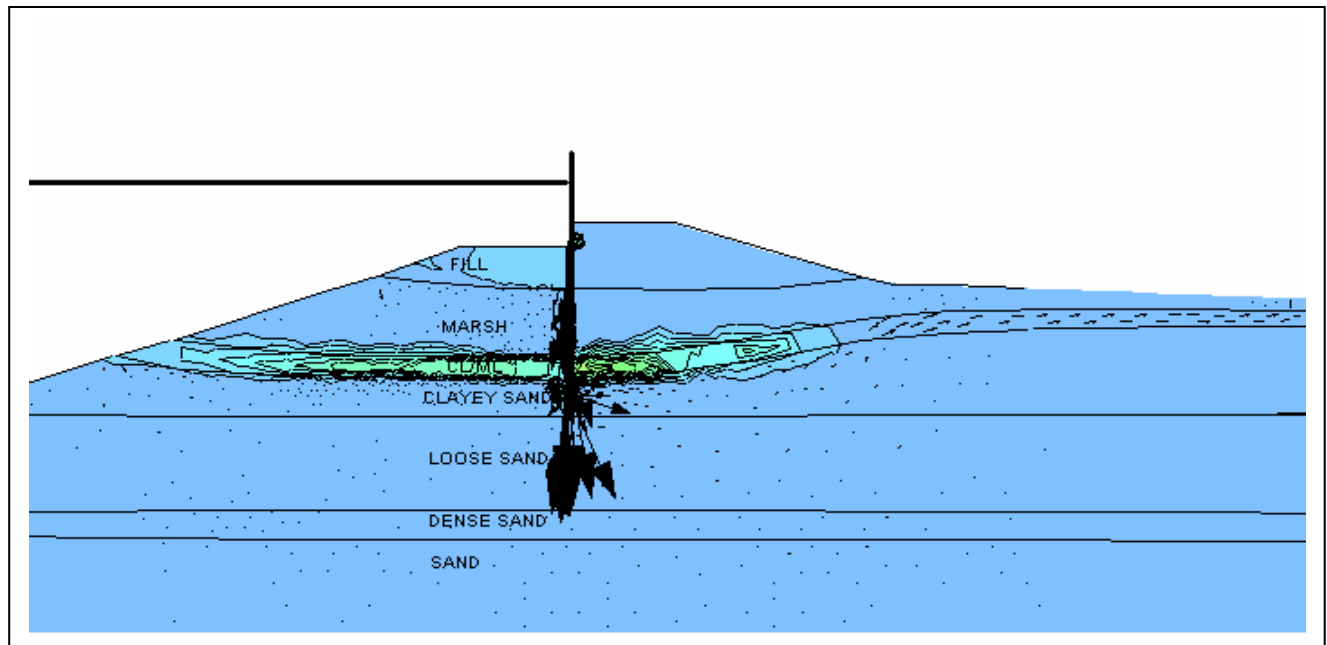
Figure 8.156: Hydraulic gradient contours with the gapping in the outboard toe of the floodwall, London Avenue Canal North, East bank. Storm surge at 9ft (MSL). Exit gradient at the inboard toe is 0.25.

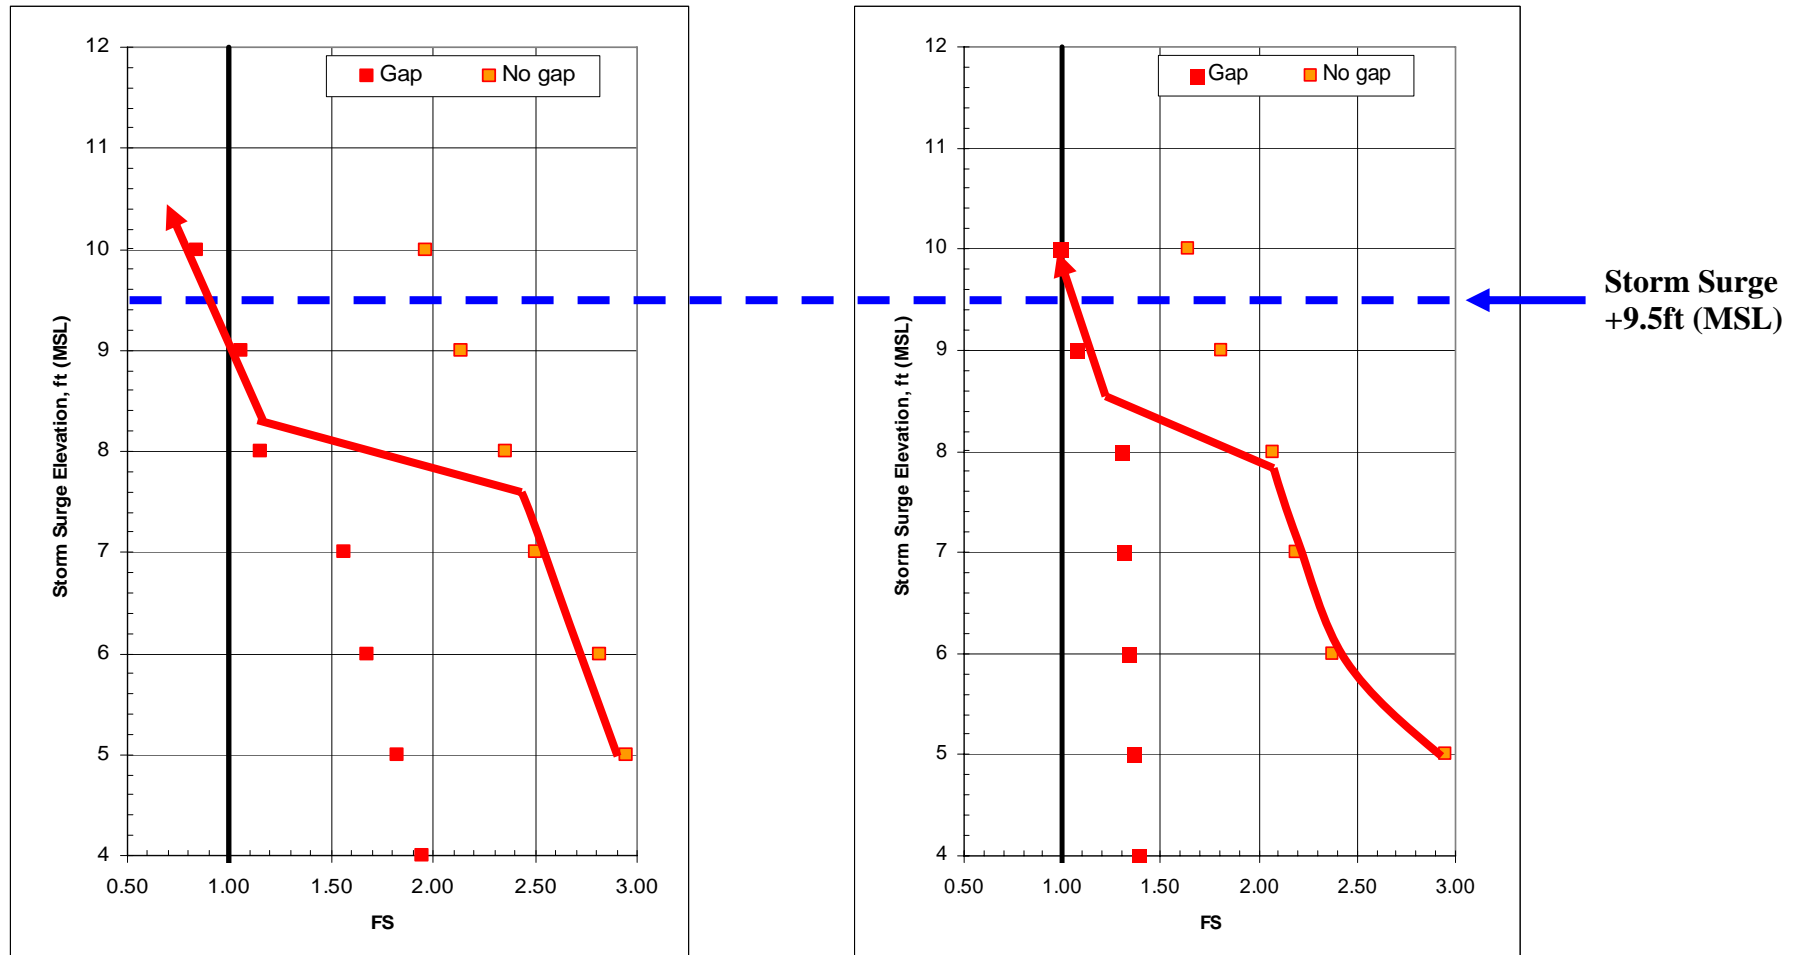
Figure 8.159: Calculated Factors of Safety for two modes based on Limit Equilibrium Analyses of the London Avenue Canal breach and distressed section for various canal water elevations; showing the best-estimated path to failure.

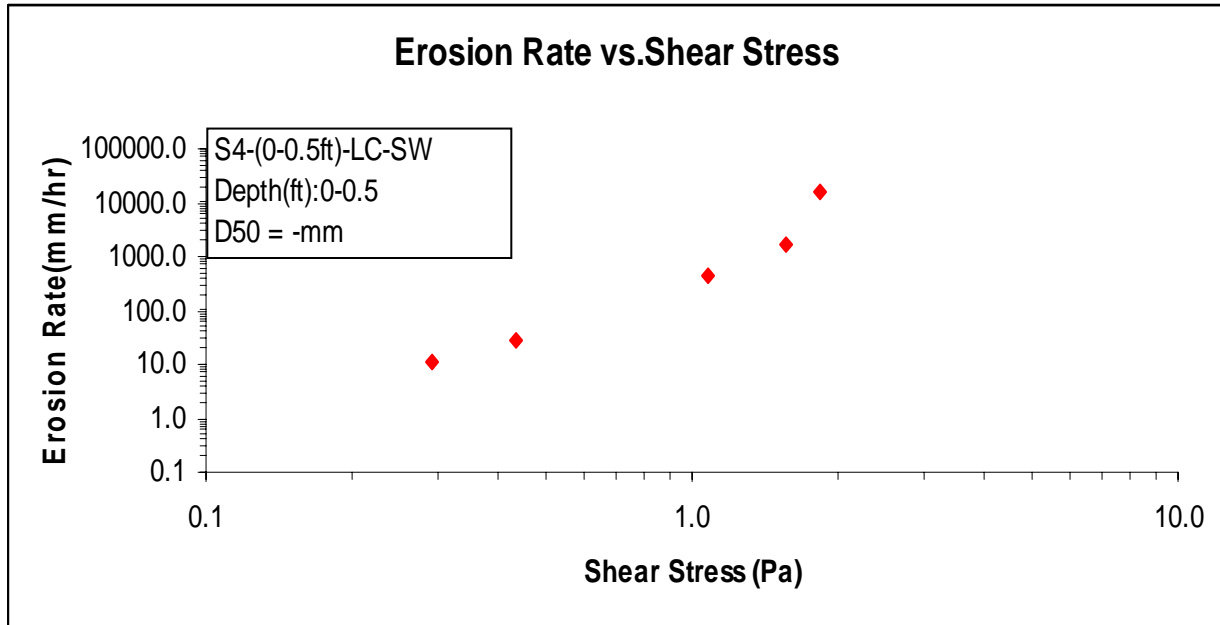
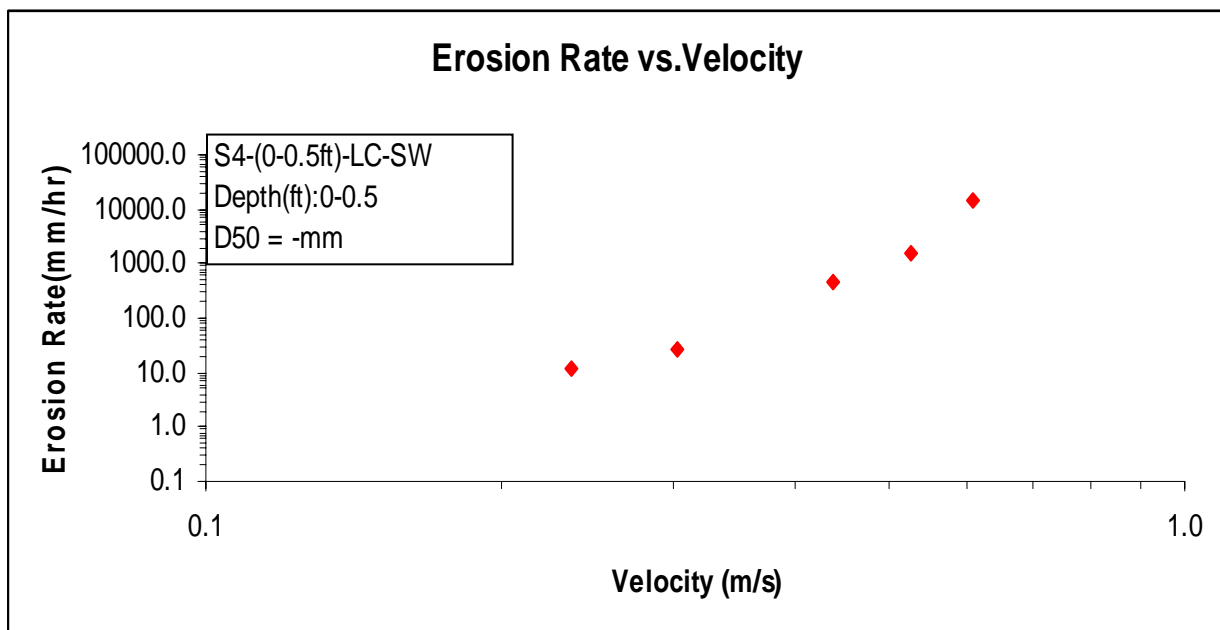
Figure 9.38: EFA test results for sample S4 (0-0.5 ft), low compaction, salt water.

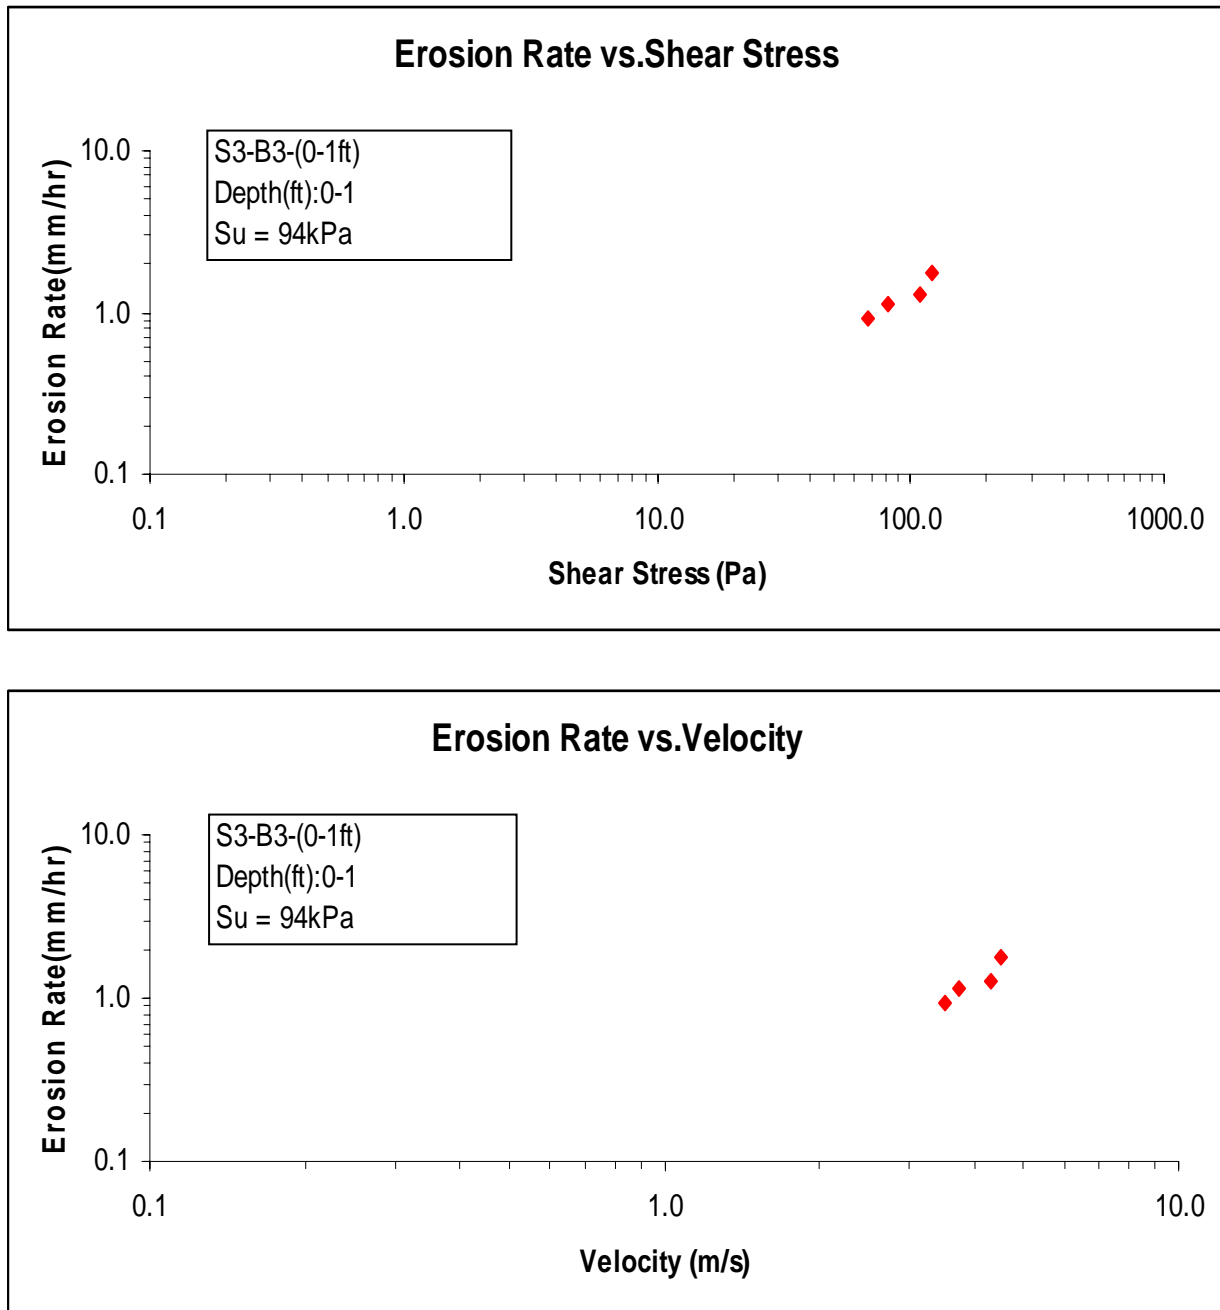
Figure 9.39: EFA test results for sample S3-B3 (0-1 ft), salt water.

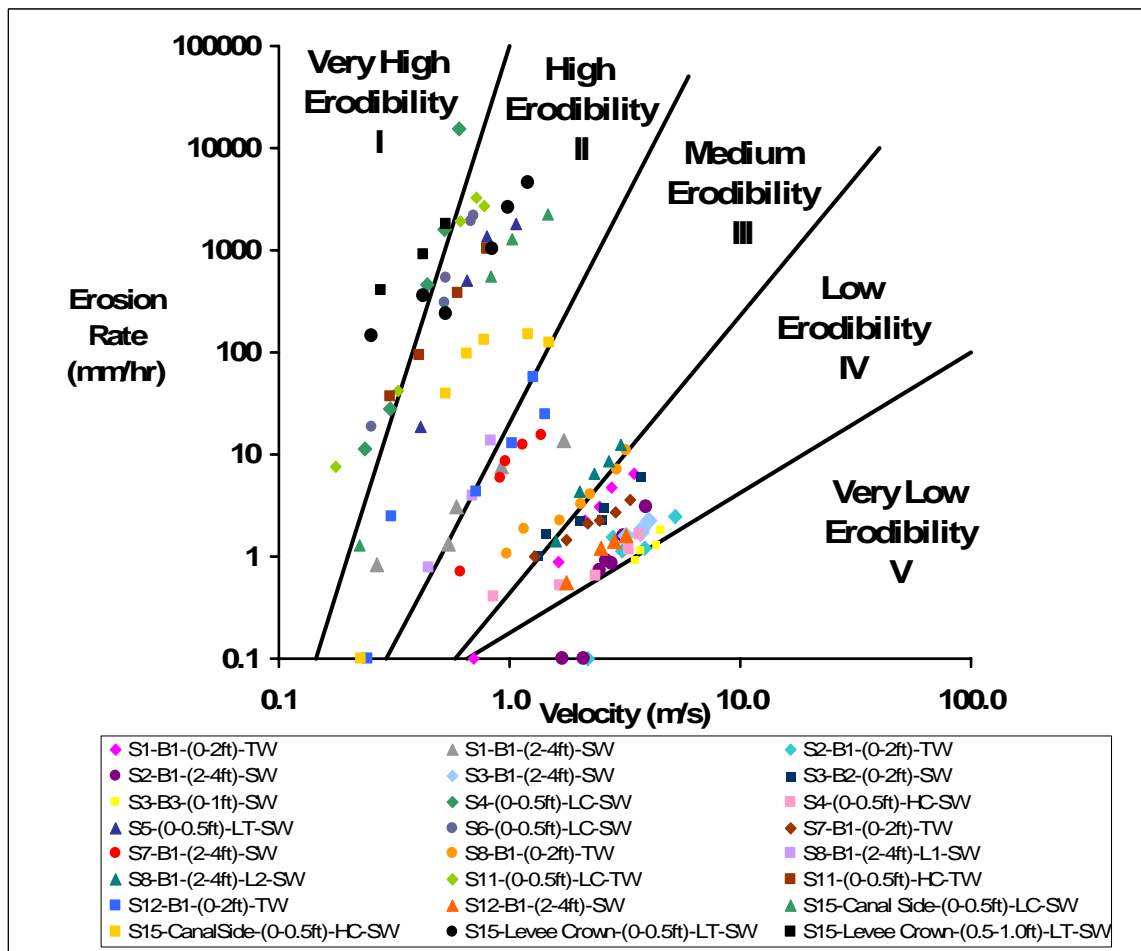
Figure 9.41: EFA test results for 24 levee samples.
